INDUSTRY WASTE STUDY. THE HAWAII SUGAR INDUSTRY WASTE STUDY

Environmental Protection Agency
San Francisco, California

June 1971

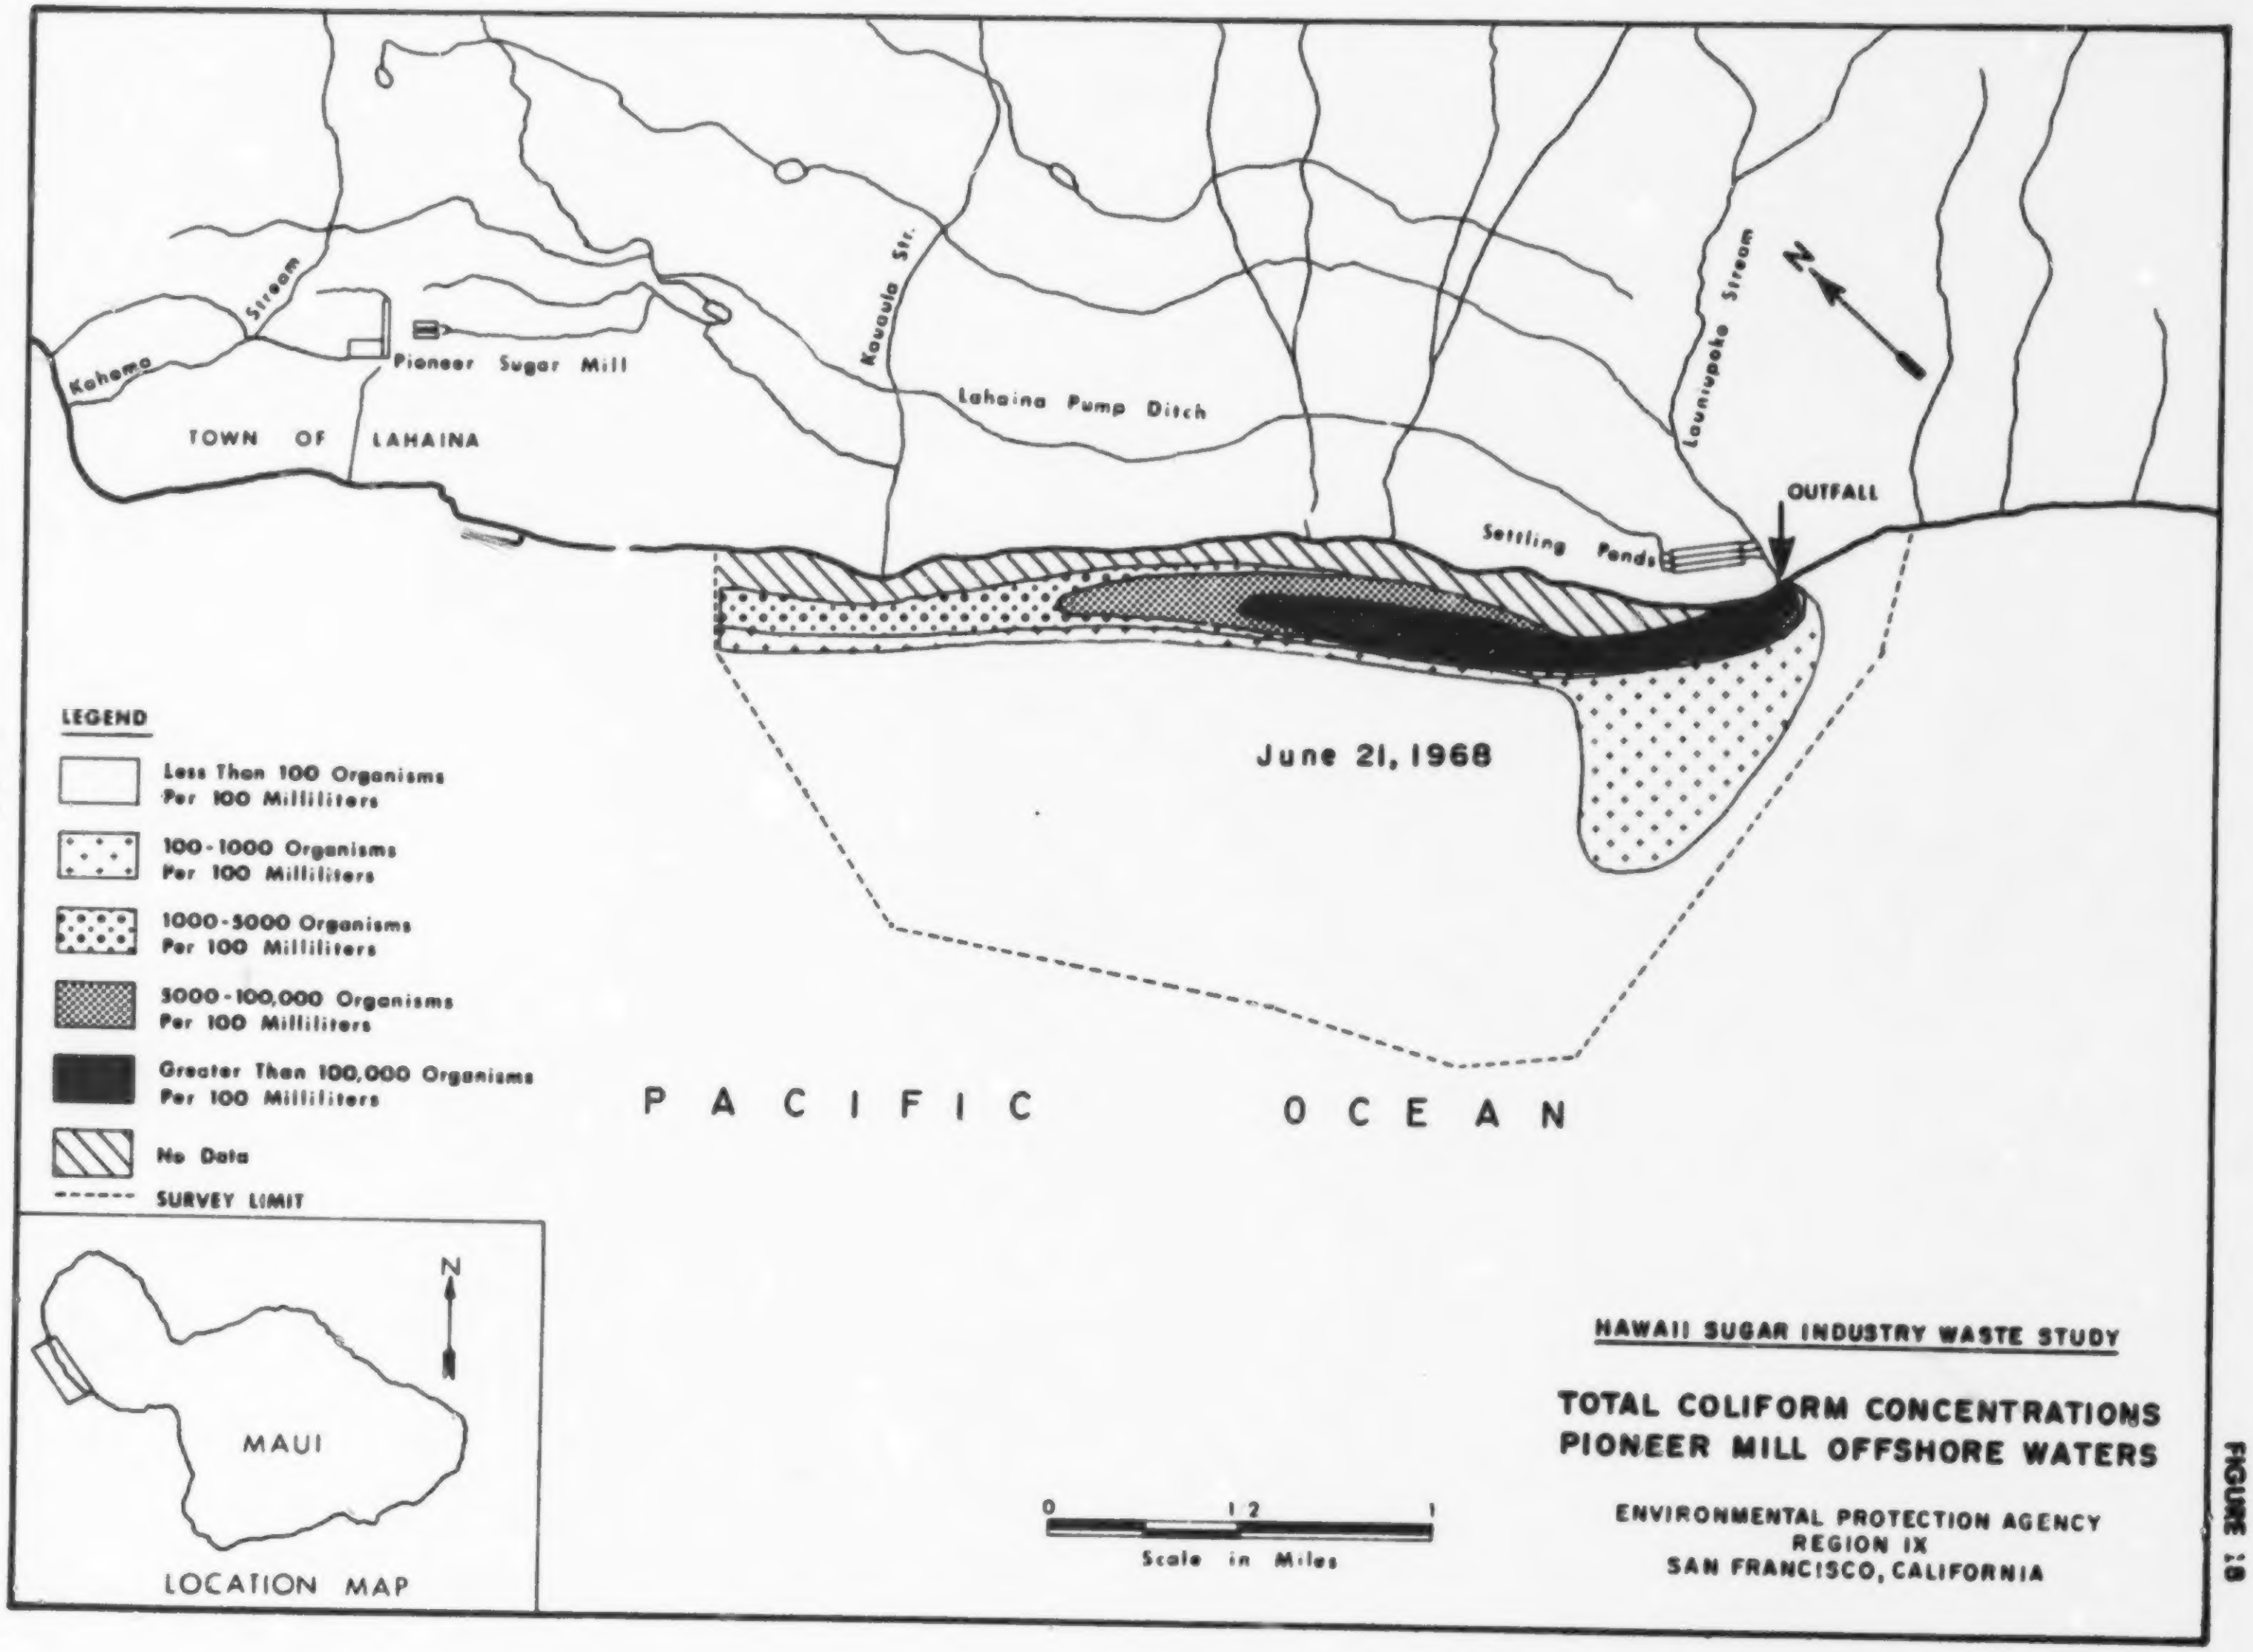
FIGURE 18

Pioneer Mill: Figure 18 indicates the total coliform values observed in the offshore waters of Pioneer Mill on June 21. As previously noted, sampling was done on other days but meaningful patterns could not be obtained from the averages because of the varying directions of the plume. In this case, the plume was observed to be heading northwest along the coast in a pattern similar to that appearing in Figure 18. Densities as high as 5000/100 ml, were observed at a distance of approximately 2 miles from the outfall.

After release of the mill discharge to the ocean, the Pioneer Mill plume (Figure 18), indicating the result of one day's sampling, shows a surface area of more than 250 acres in which total coliform densities exceed 1000/100 ml, a generally accepted limit for water classified as "safe" for water contact sports. The distance that the elevated densities continued is a matter of speculation; however, based on a count of 3400/100 ml at the westernmost sampling point, densities greater than 1000/100 ml may have existed at a distance offshore from Lahaina, a town located three miles west of the discharge point.

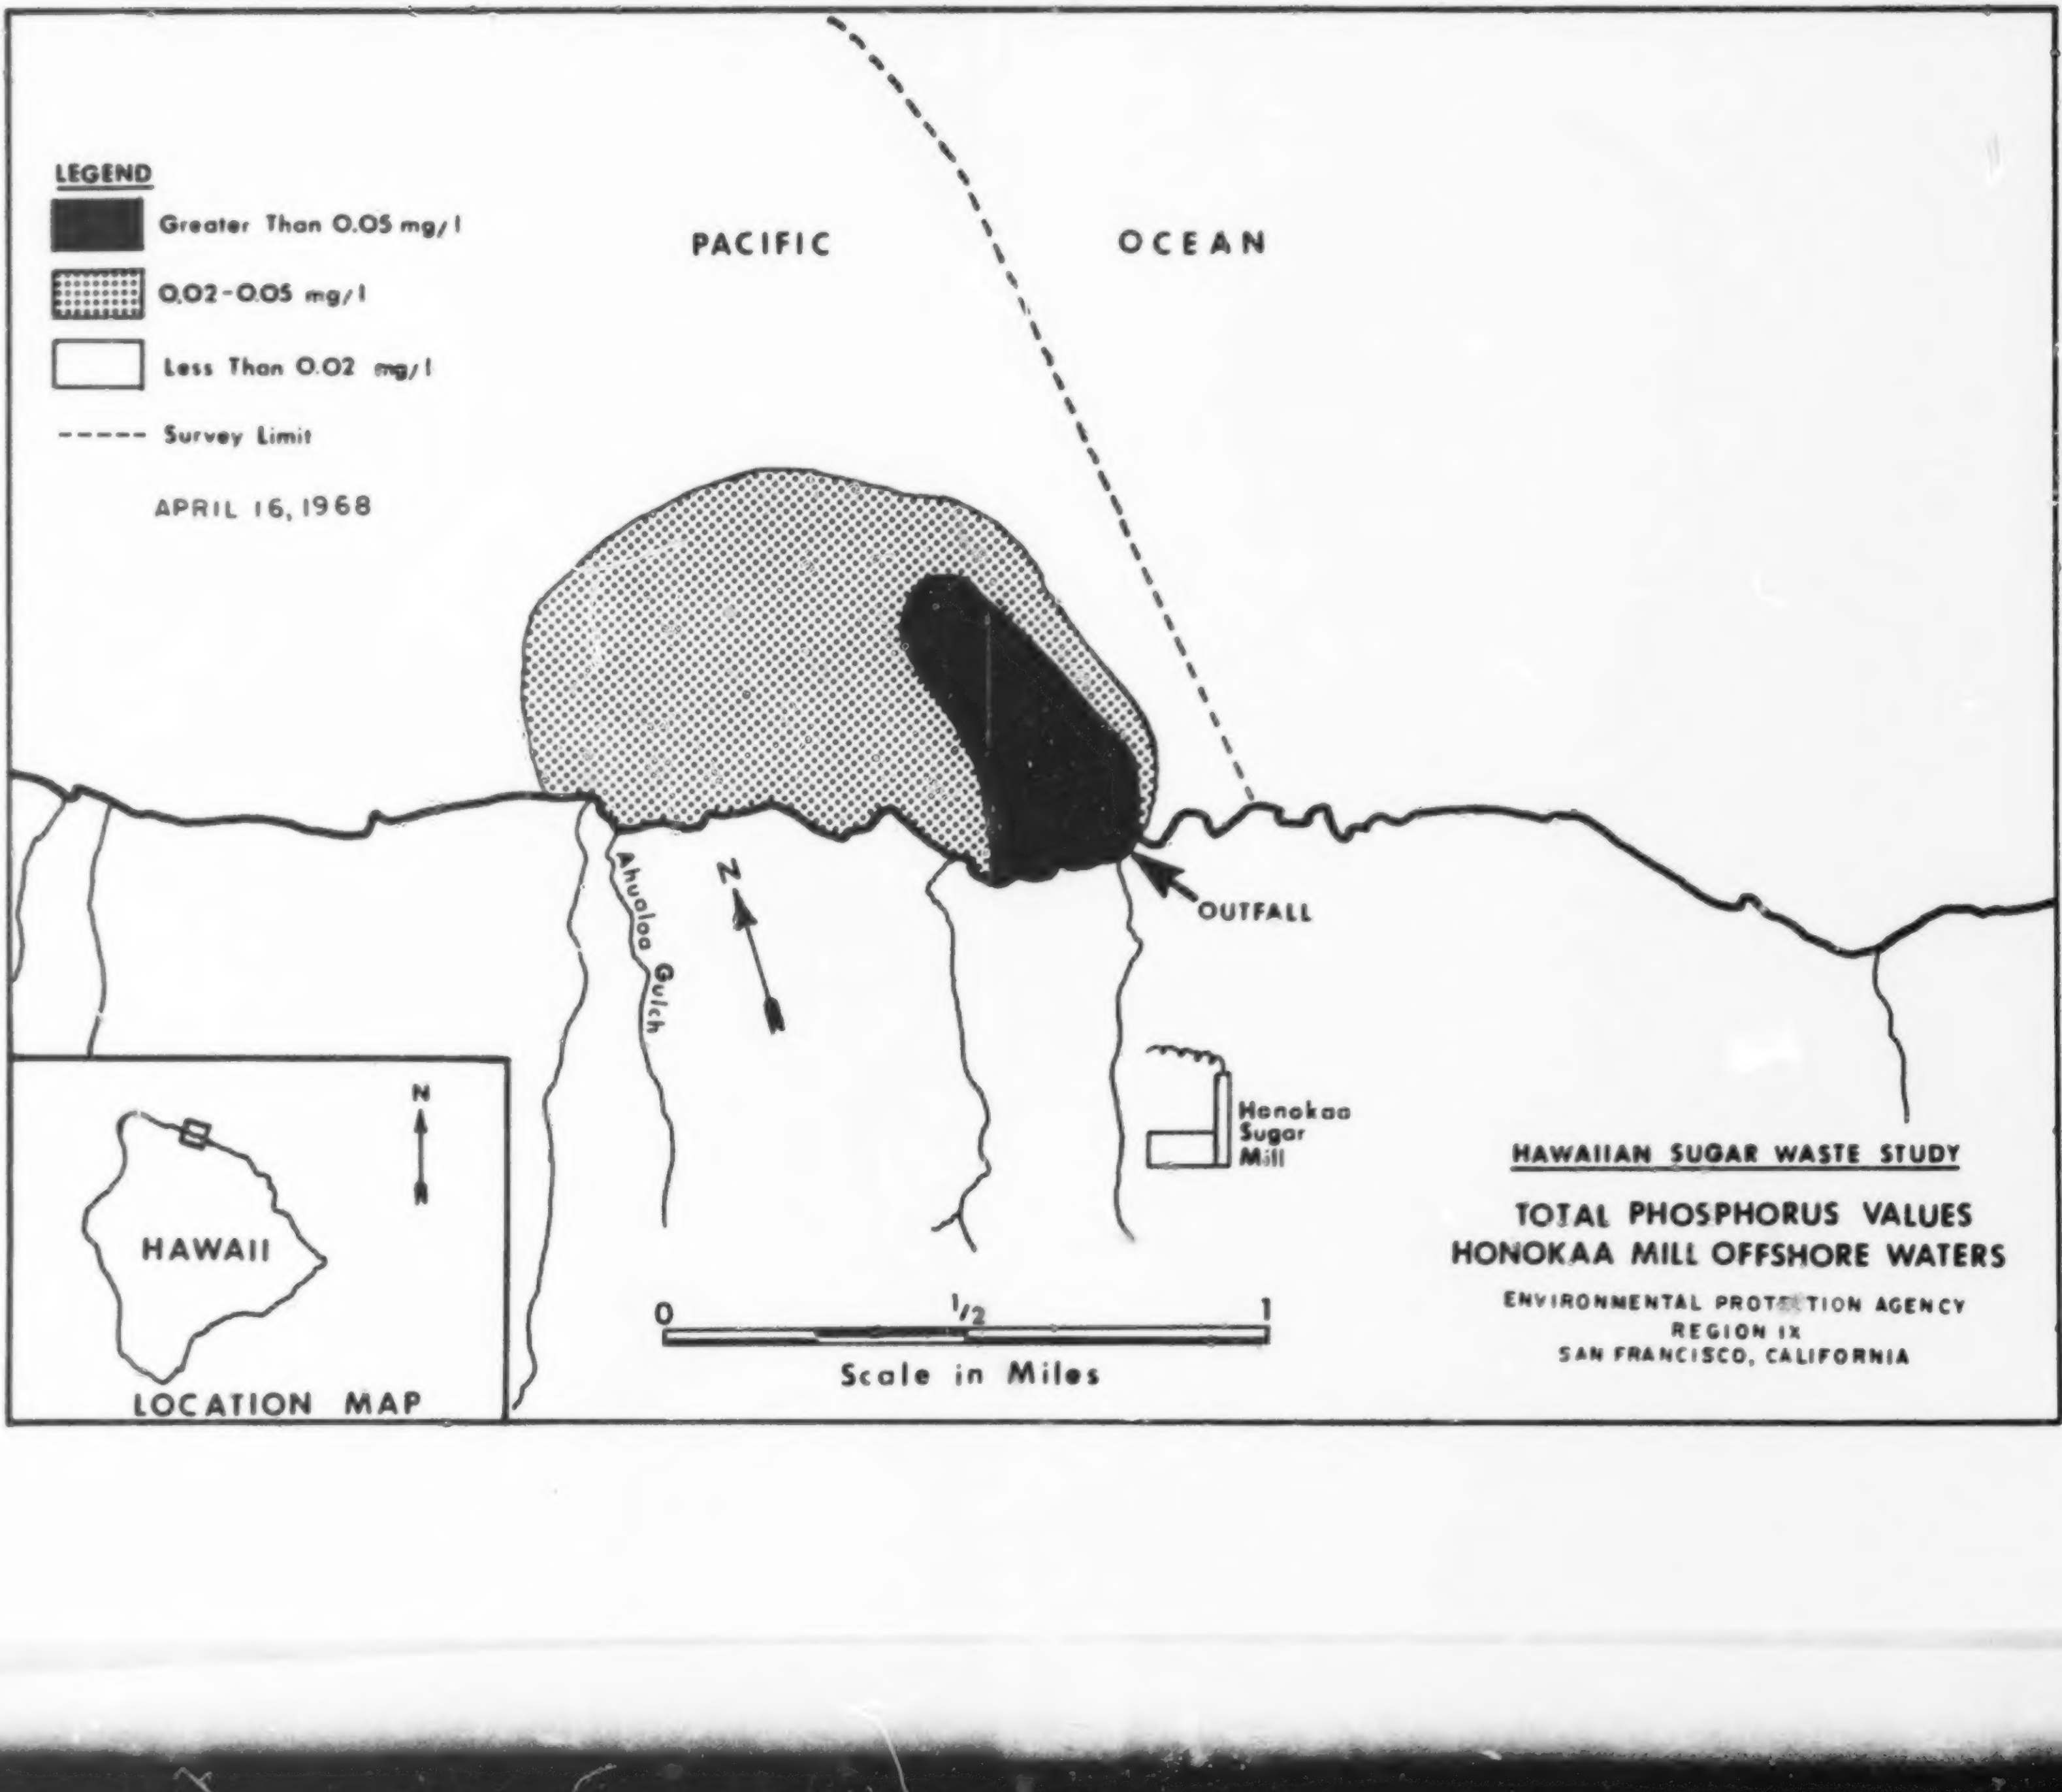
FIGURE 19

Total Phosphorus: The total phosphorus values at the near shore stations off Honokaa Mill generally showed either uniform distribution from top to bottom, or higher values at the surface in the plumes. The depth of water increases rapidly offshore of the mill, and during the spring survey higher values were noted near the bottom at the deep water stations. These figures formed a semi-circular pattern and are presented in Figure 19. The plume was also observed to be traveling in the same pattern during the sampling period.

The in-plant surveys revealed that the mill wastes contained significant concentrations of total phosphorus, and Figures 19 and 20 show that the discharges can be detected for some distance from the outfall locations at Honokaa and Pioneer Mills. No similar pattern could be recognized in the Olokele discharge because of a smaller volume of effluent. The figures indicate that the numerical values for normal sea water were exceeded for a distance of approximately one mile in the direction of the travel of the plume at both Honokaa and Pioneer Mills on April 16 and June 19, respectively. Approximately 375 acres of surface waters showed phosphorus values over 0.02 mg/l at both mills on those days.

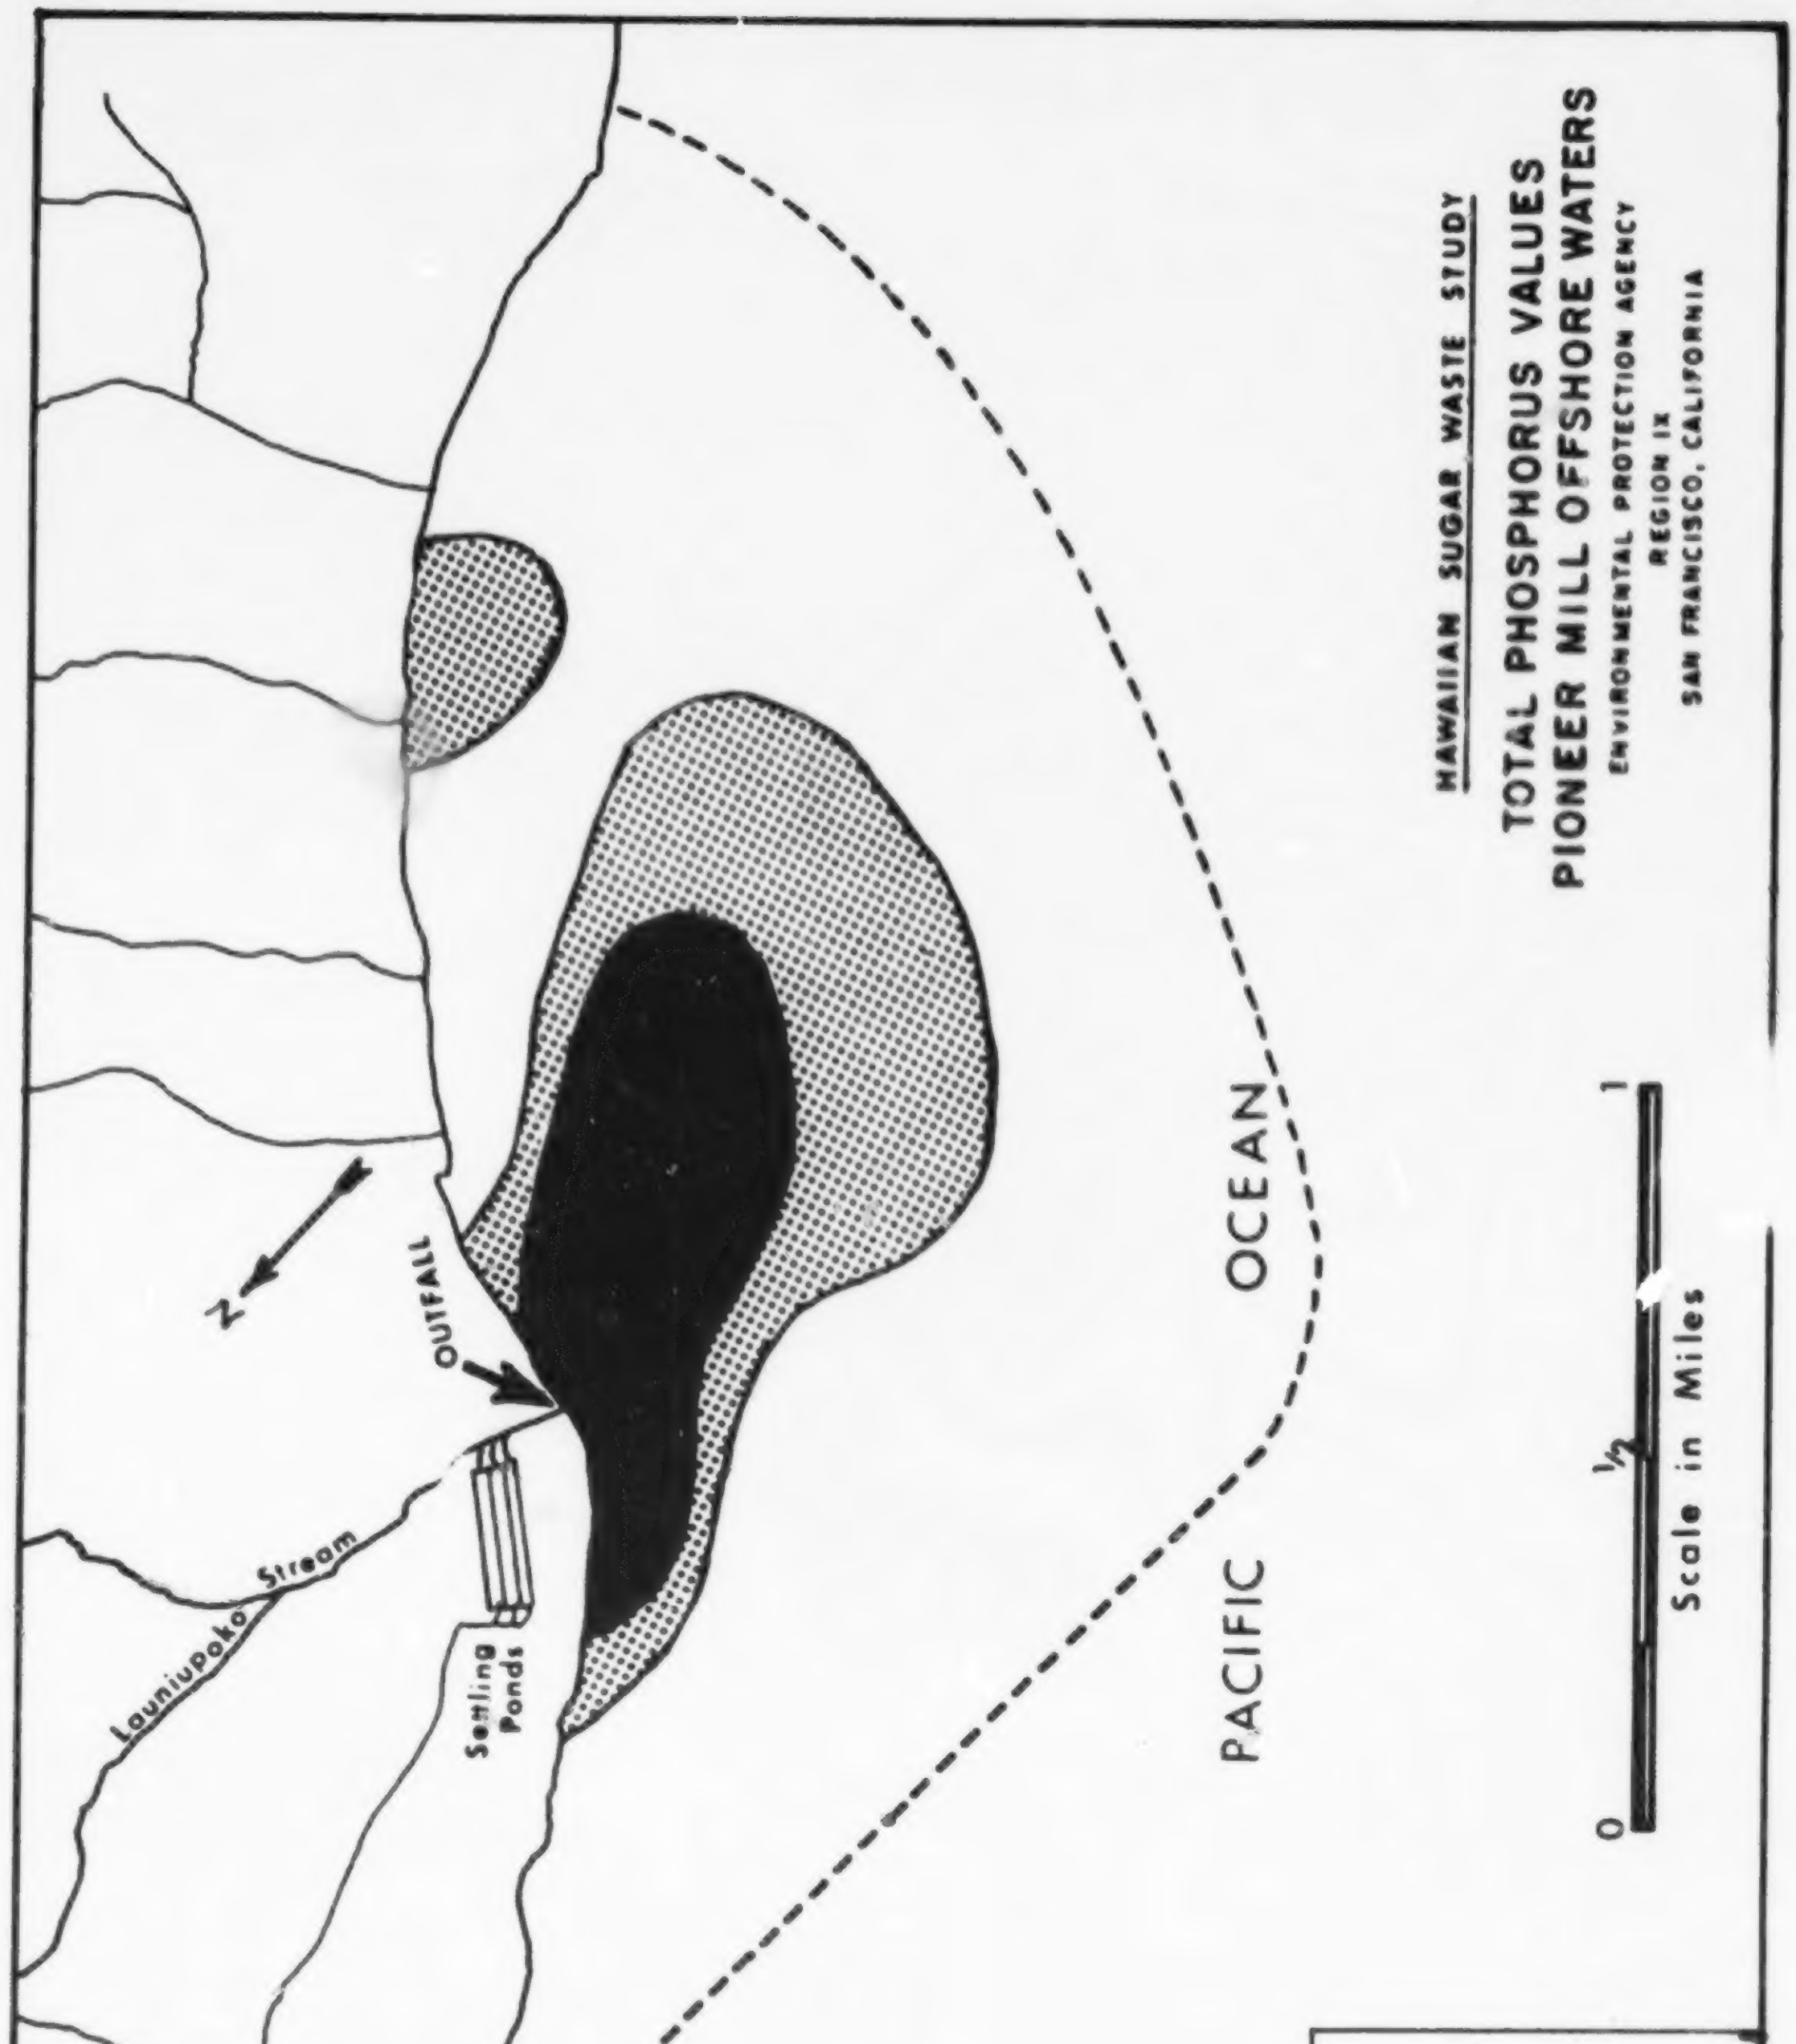
FIGURE 20

Total phosphorus values offshore of Pioneer Mill showed fairly uniform distribution from top to bottom except near the outfall where the effect of the plume stratification was noted. Results from samples taken at the deeper water locations showed less evidence of higher values at the bottom. An elliptical pattern was noted in the values during the June survey and is shown in Figure 20. The observed turbidities also formed a similar pattern.

TOTAL PHOSPHORUS VALUES
PIONEER MILL OFFSHORE WATERS
ENVIRONMENTAL PROTECTION AGENCY
REGION IX
SAN FRANCISCO, CALIFORNIA

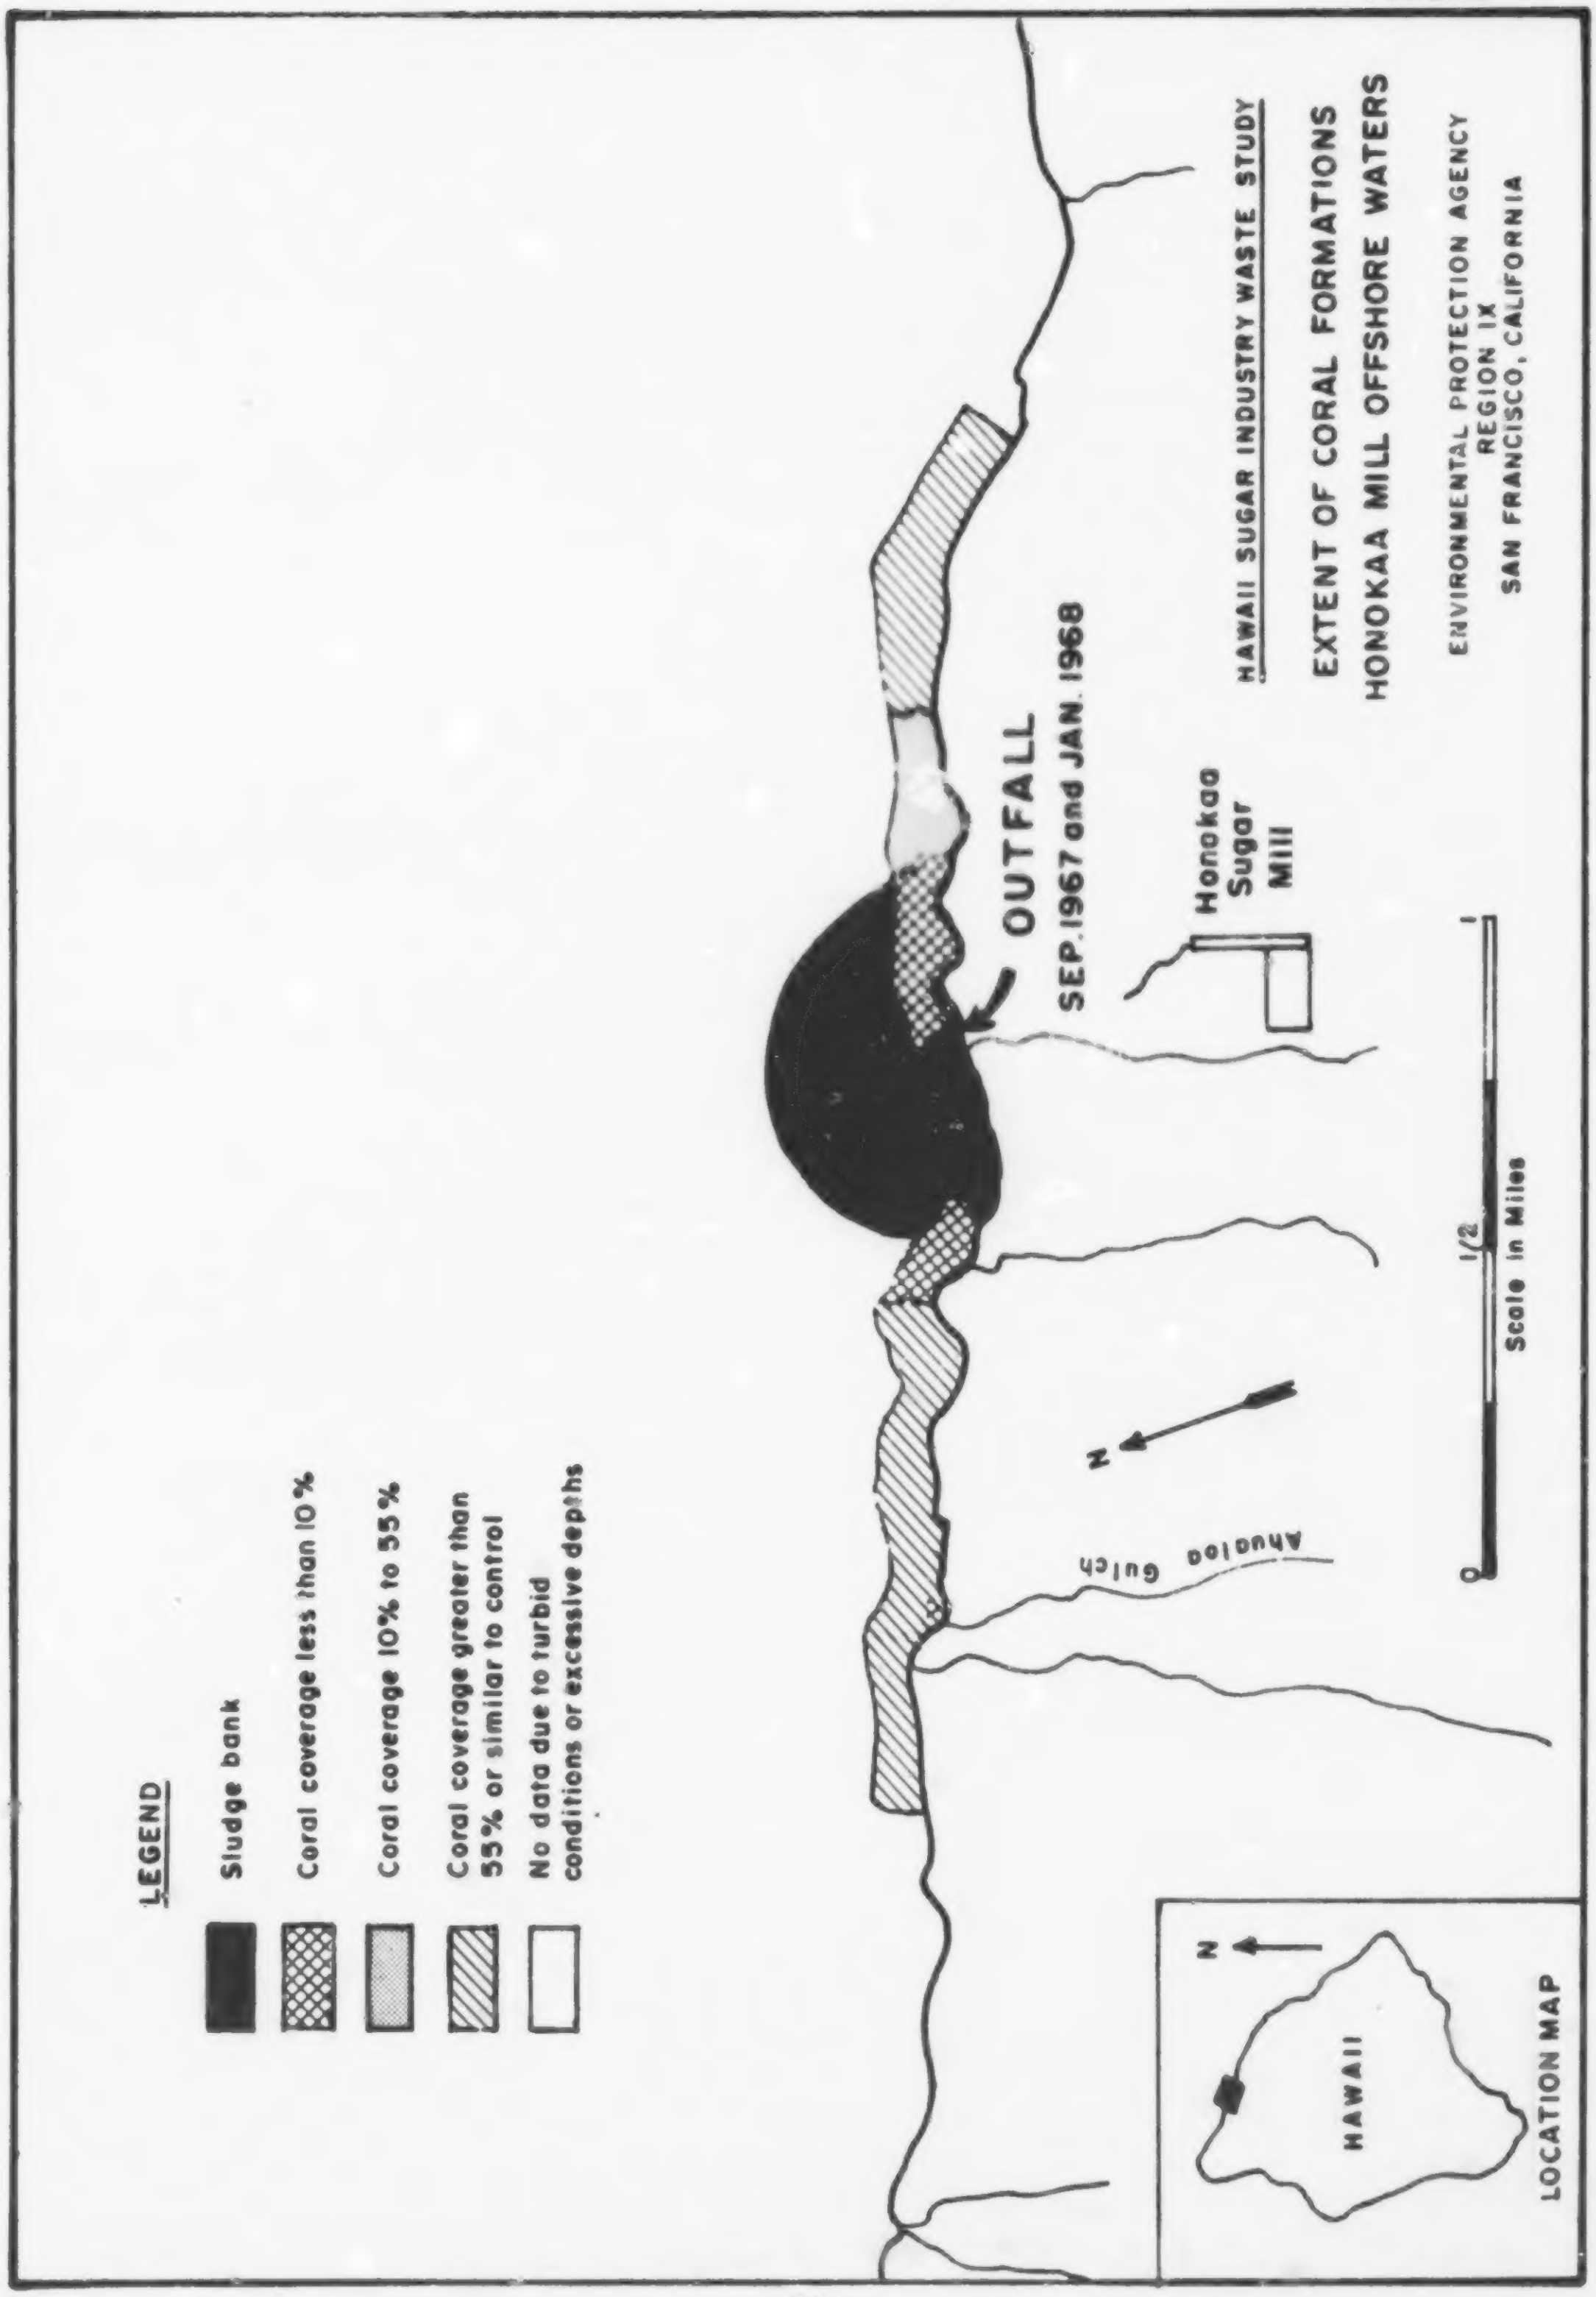
FIGURE 21

EXTENT OF CORAL FORMATIONS
HONOKAA MILL OFFSHORE WATERS

Good observations were possible along the shoreline at the Honokaa Mill. From observation, the actual area of coral reef which was altered by mill discharges could not be precisely determined. It was observed that within 0.75 mile along the shoreline the coral was undamaged. Observations at the Pioneer Mill showed unaffected coral at 300 yards from the outfall. Less is known about the area of influence at Olokele Mill, although available data (Figure 28) show

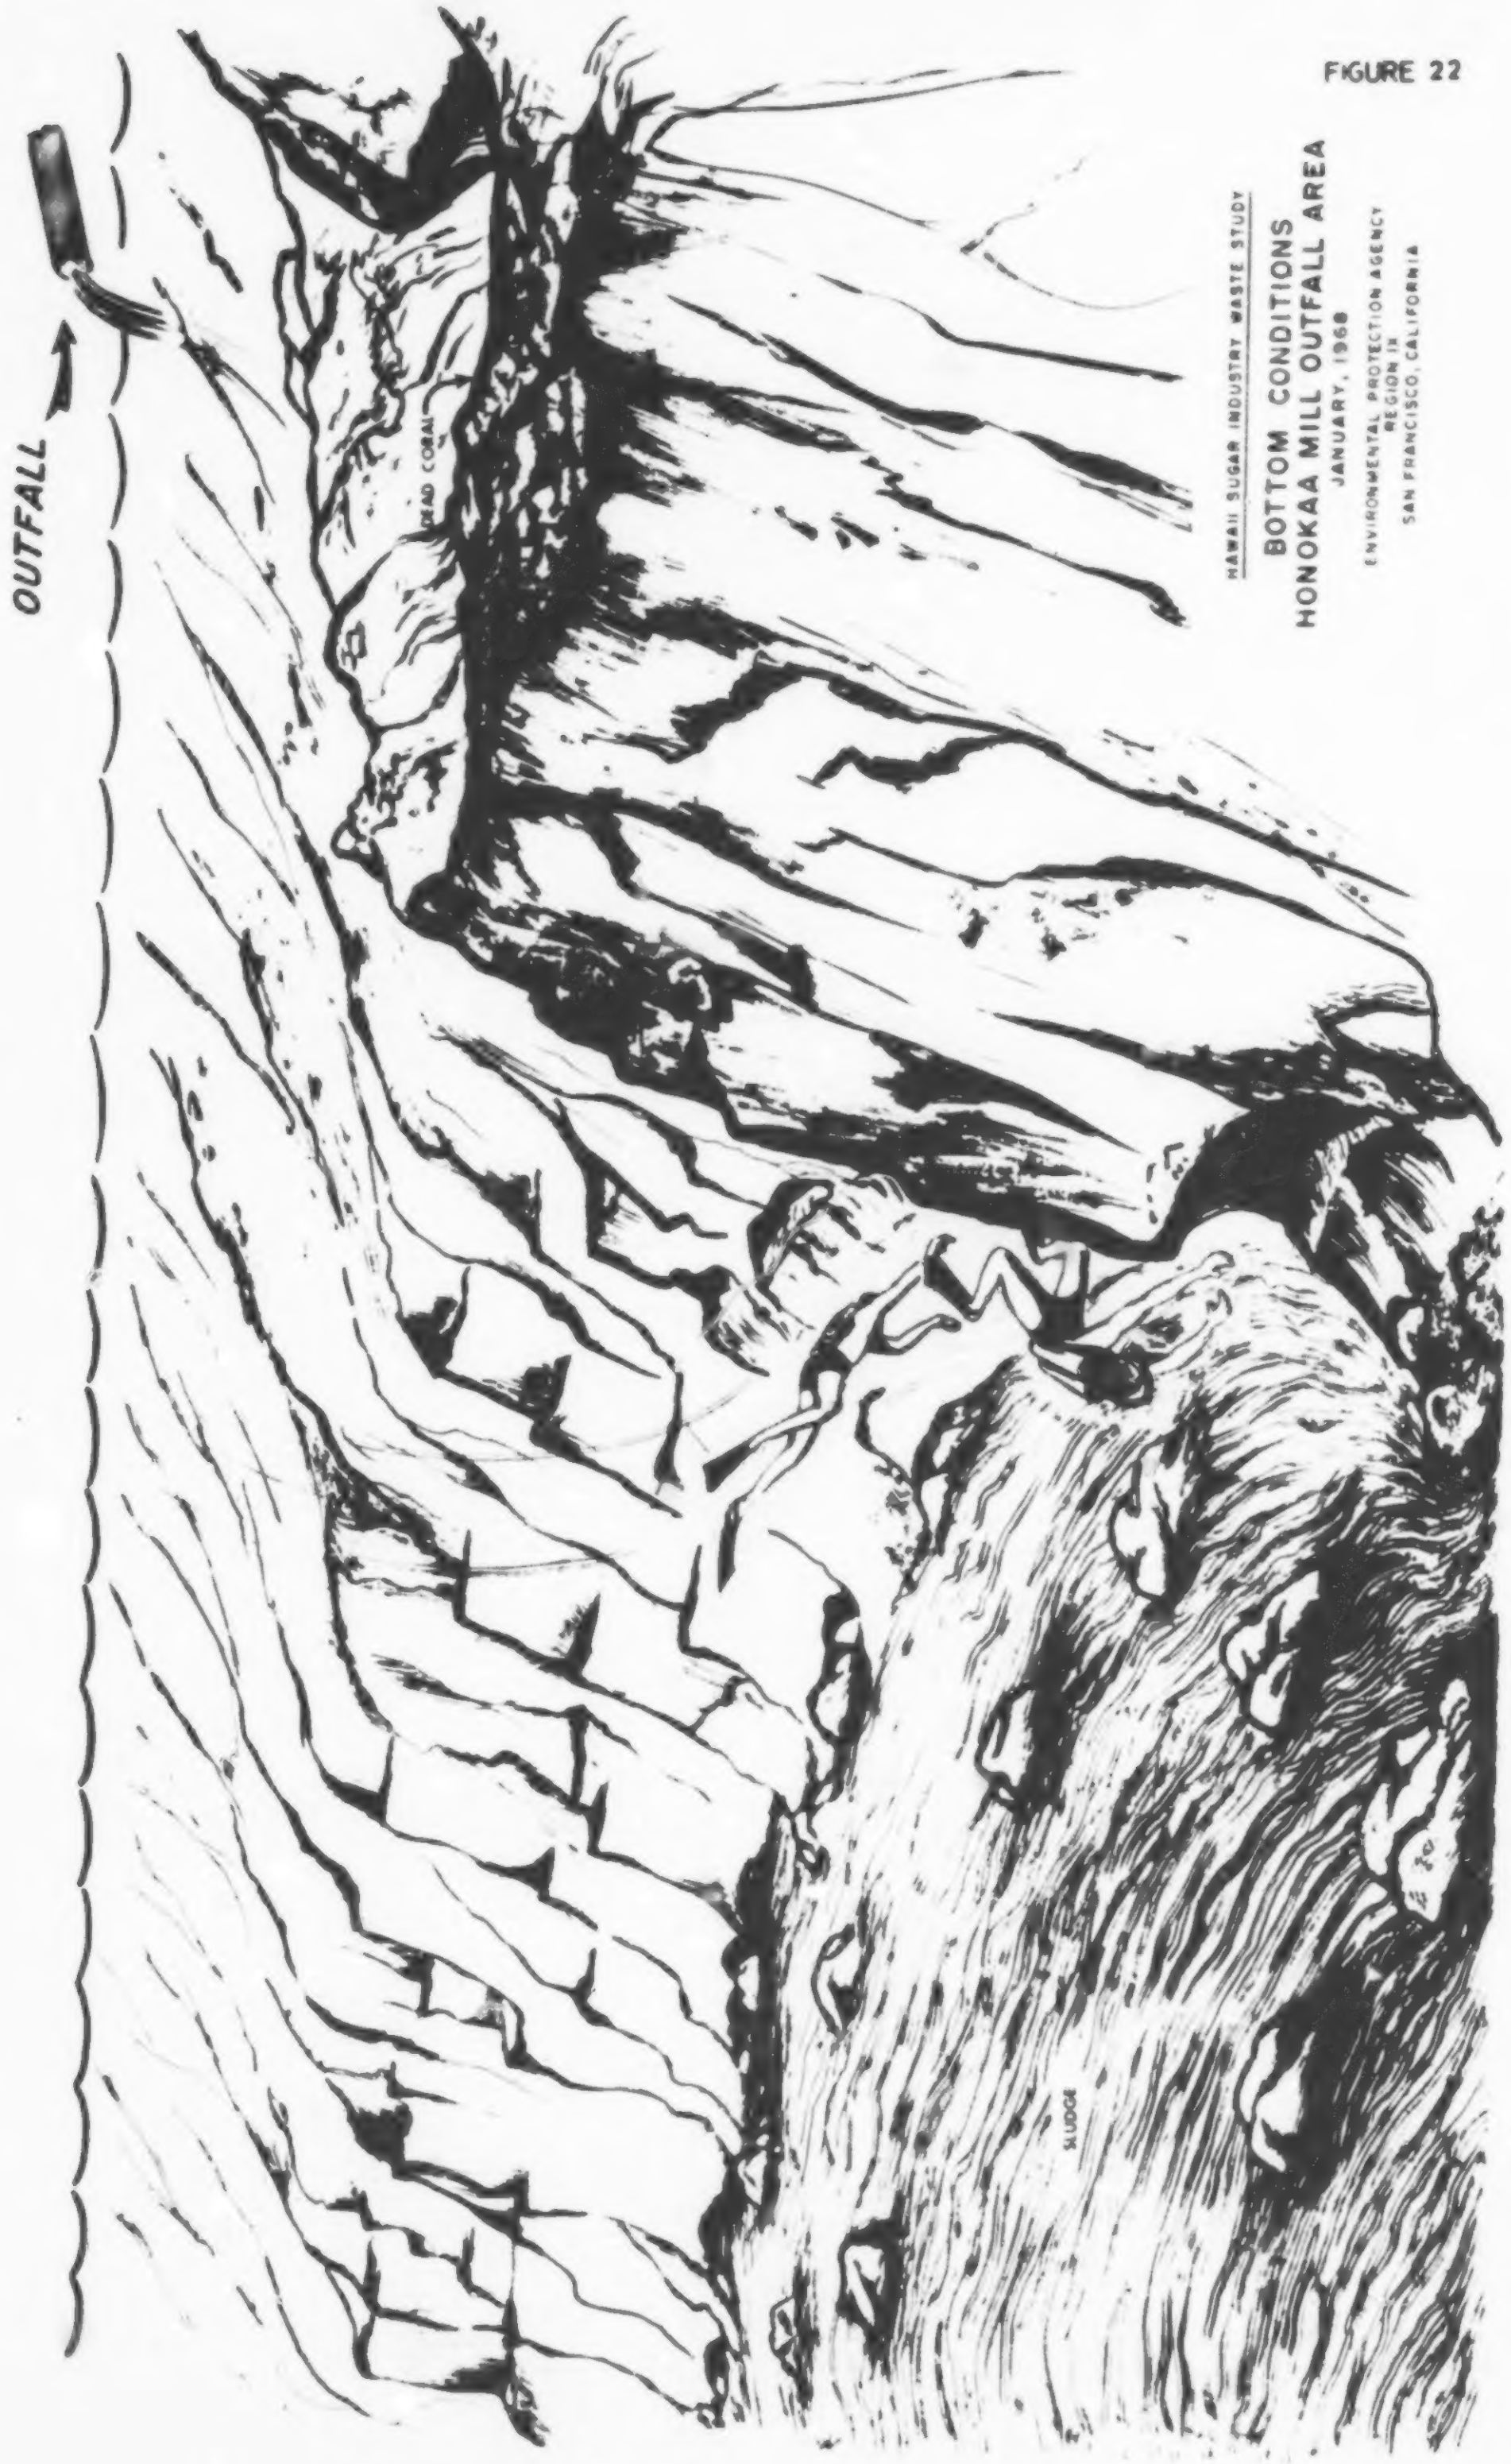
FIGURE 22

OUTFALL
DEAD CORAL
SLUDGE

BOTTOM CONDITIONS
HONOKAA MILL OUTFALL AREA
JANUARY, 1968
